Controlled Shear Point Technology Case Study

Deployed on Floating Docks - Pleasant Harbor Marina, Lake Pleasant Arizona

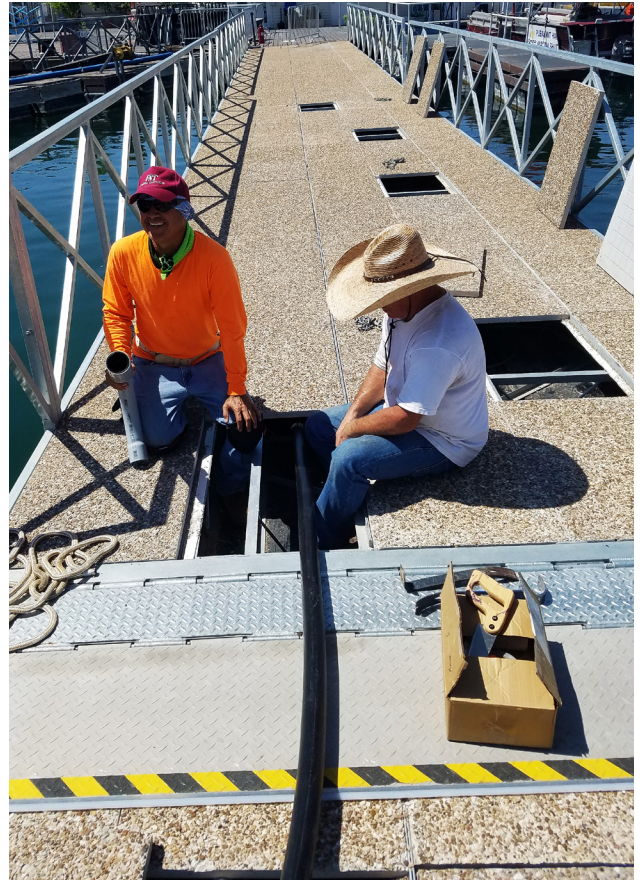
In consideration for re-design of cable TV services and communication circuits consisting of dedicated fiber optic for each slip, as well as the marina office complex, restaurant, fuel dock and other amenities, the project engineers opted for a design which would allow cable connections to flex by as much as 15 feet and provide for catastrophic protection in the event of repeat storm surges.

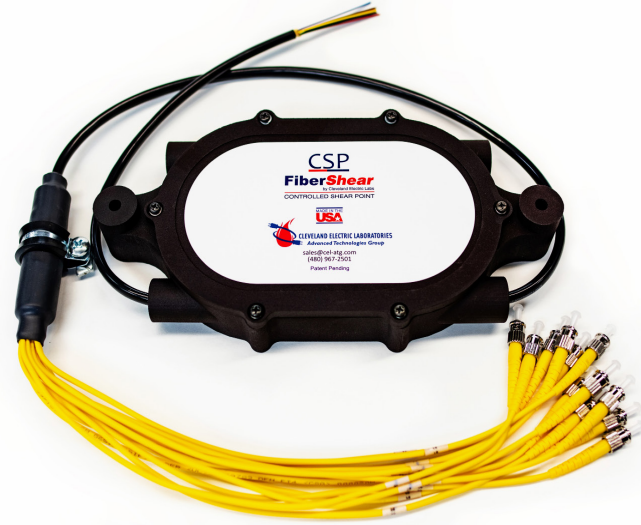
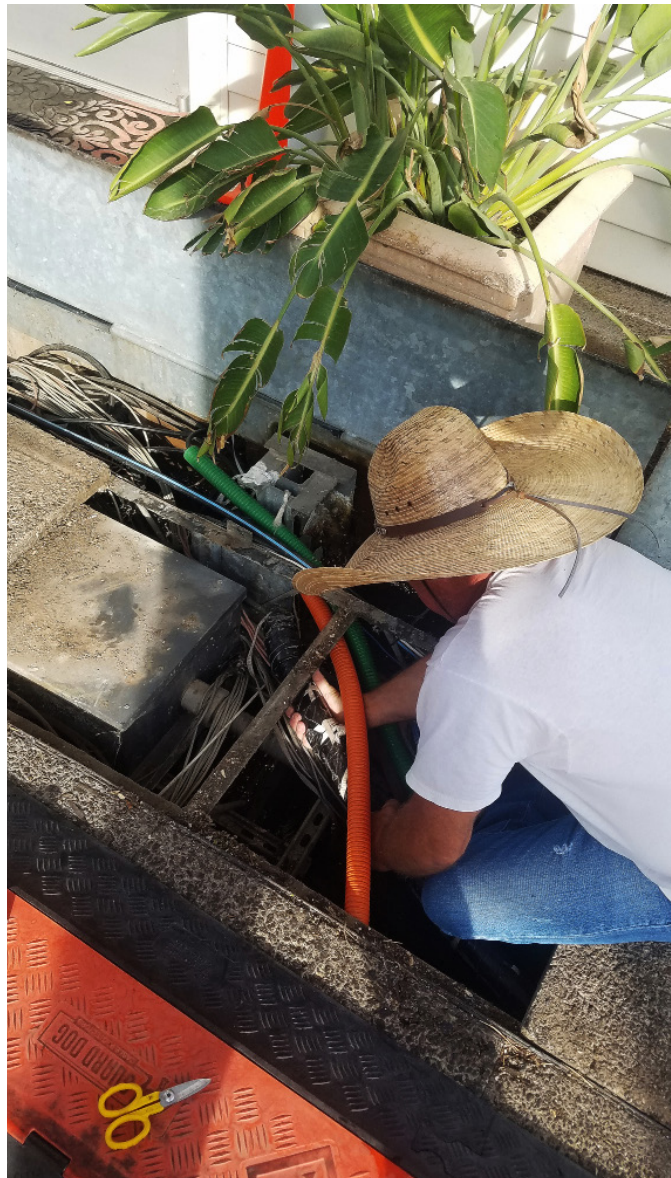
Along with providing the emergency slack needed, the CSP module is designed to cleanly cut or shear off the fiber in a controlled enclosure so that a quick and simple splice can be performed in the event of an emergency breakaway.

By adding cable slack loops to absorb up to 15 feet of the anticipated initial flex movement, the last 6 feet of fiber cable, deemed as emergency breakaway, was easily stored within the CSP module.
